Phase I Environmental Site Assessment

55-Acre Commercial Site
College Park, Fulton County, Georgia

May 7, 2020

Cardno Project #: 0002304013

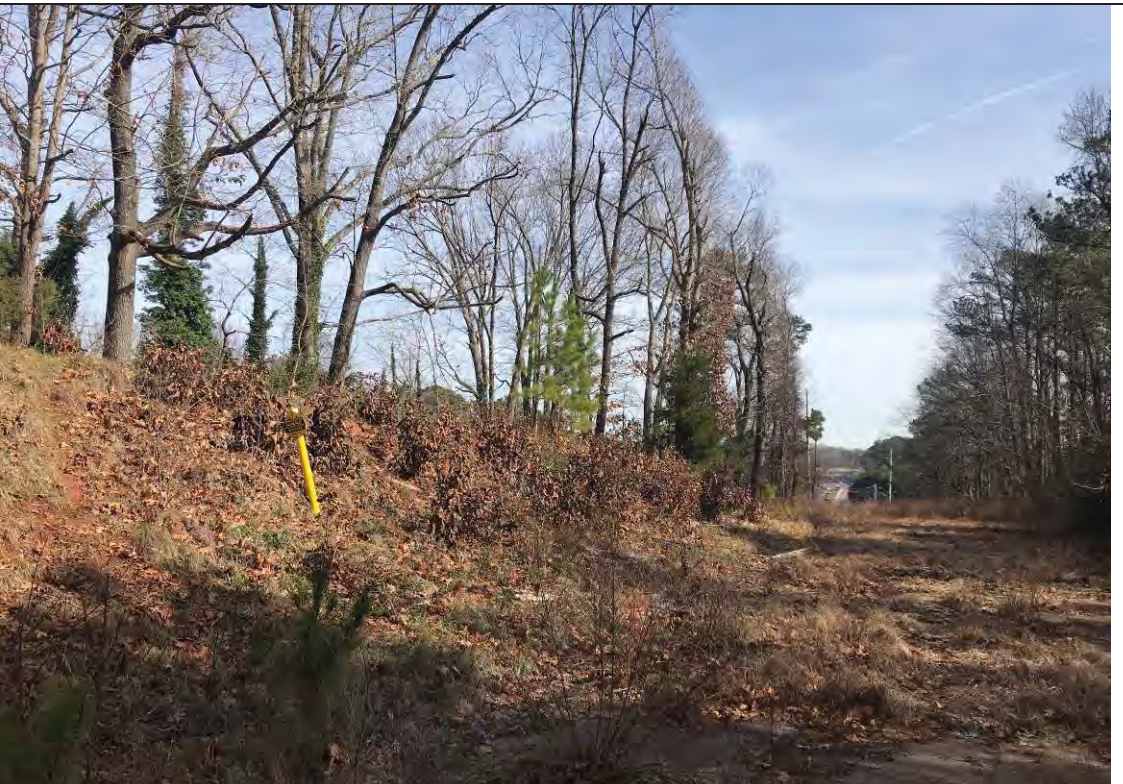
Photo No.
2

View of the petroleum pipeline and the former Paul D. West Drive.

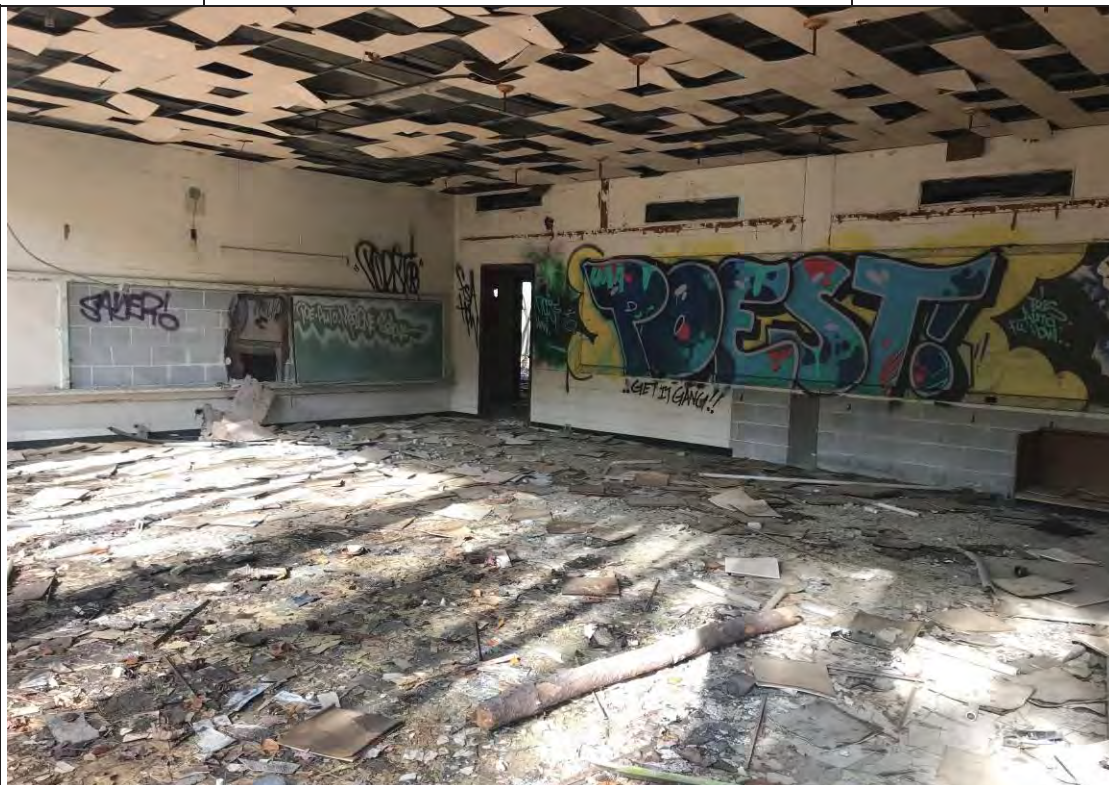
Most of these materials were in very poor condition, and inextinguishable from non-ACM debris. Given the poor condition, all building materials, with the exception of the concrete slab foundation, concrete mason unit (CMU) walling, and metal framing, should be considered friable ACM

Classrooms with suspect asbestos-containing materials (ACMs).

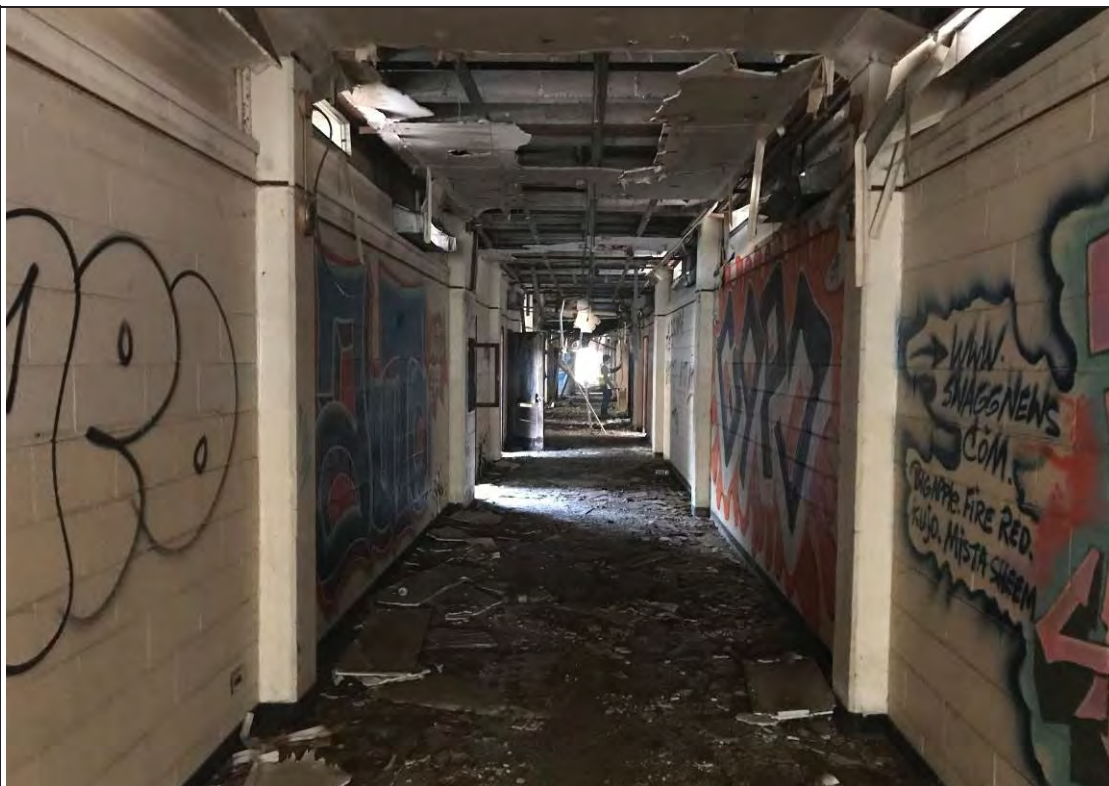
Photo No.

Hallway with suspect ACMs.

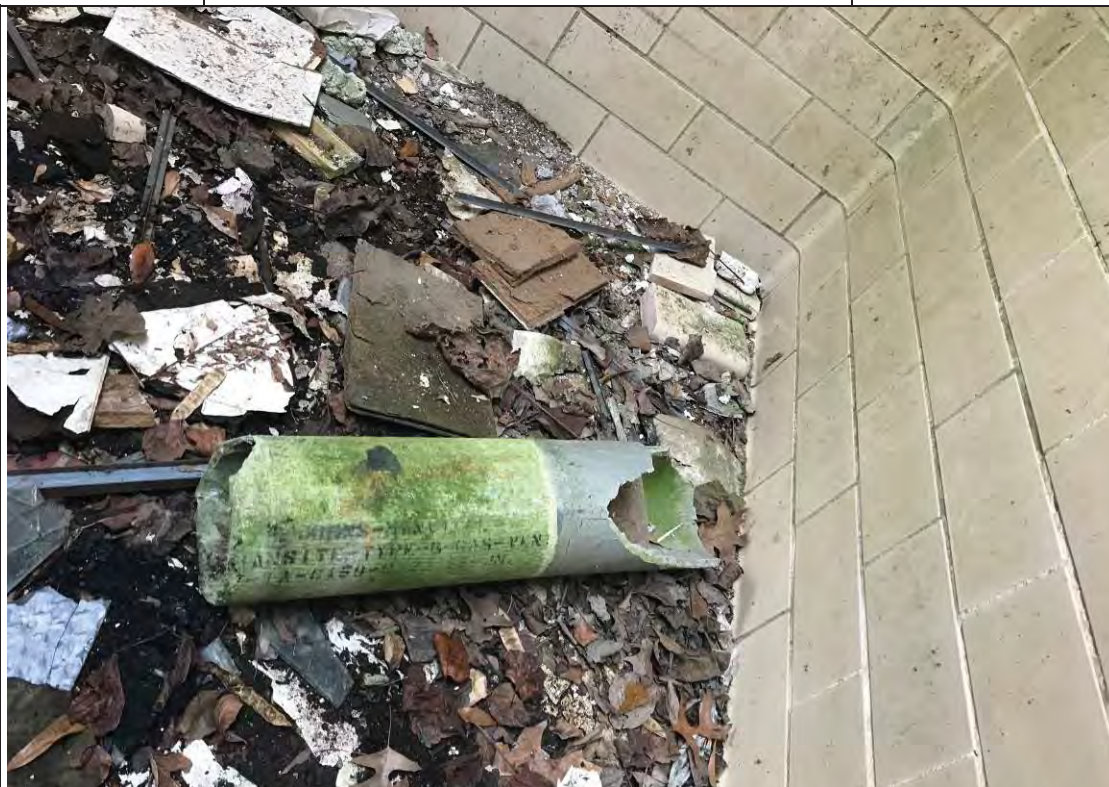
Kitchen with suspect
ACMs.

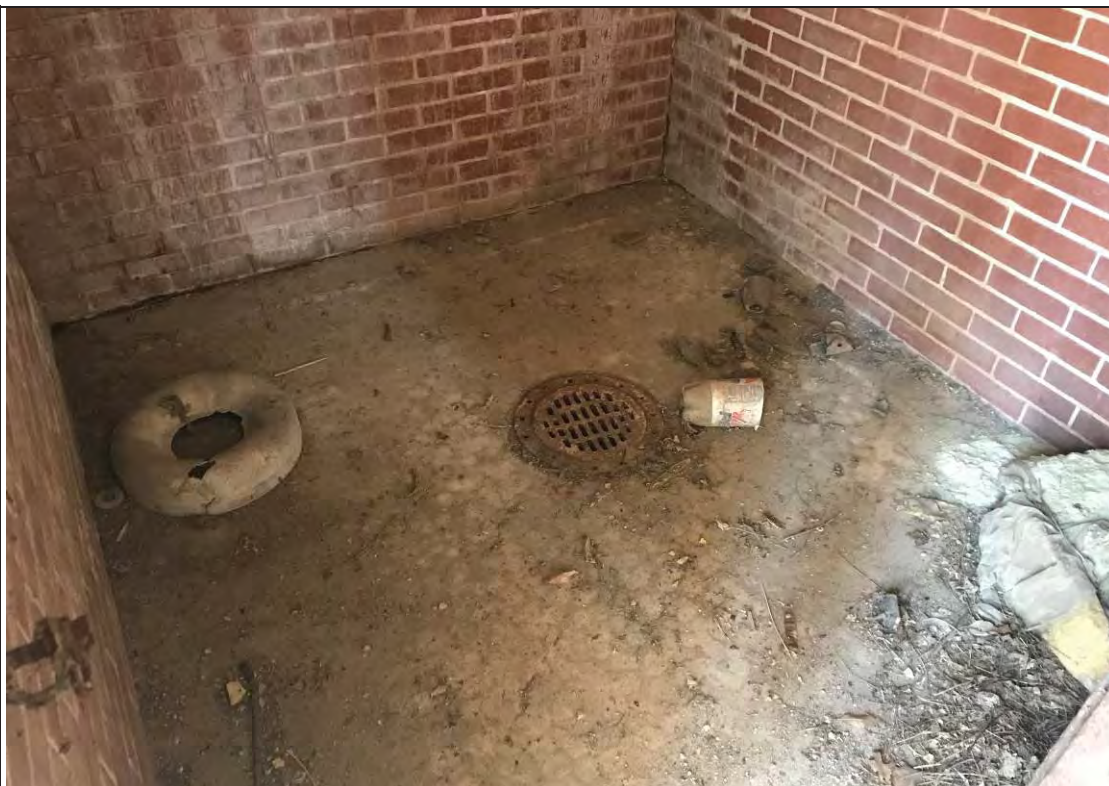
Photo No.
8

6.9	Wastewater	No	No	No	No	
6.10	Waste Pits, Ponds and Lagoons	No	No	No	No	
6.11	Sumps	No	Yes	No	No	Drains were observed in connection with the kitchen of the former Kathleen Mitchell Elementary School

A drain was observed
adjacent to the kitchen.

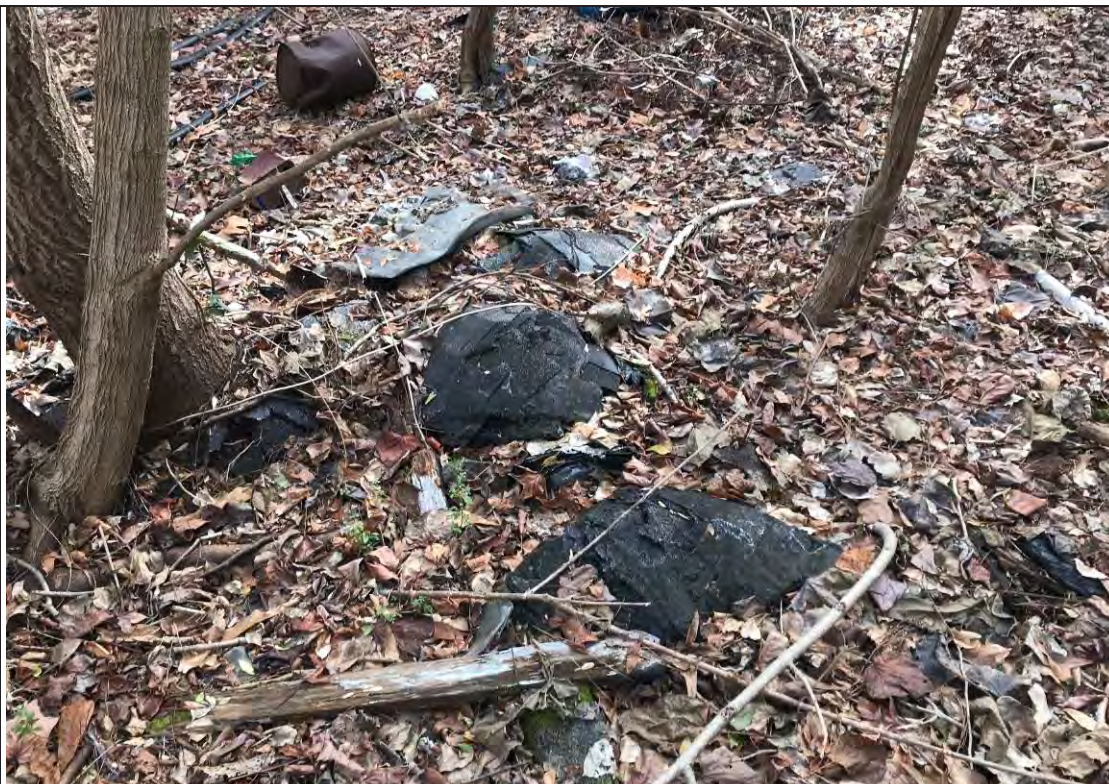
Photo No.
10

6.5	Other Petroleum Products	No	No	No	No	
6.6	Polychlorinated Biphenyls (PCBs)	No	No	No	No	
6.7	Unidentified Substance Containers	No	No	No	No	
6.8	Nonhazardous Solid Waste	No	Yes	No	No	Several piles of tires, piles of shingles, scrap metal, and debris were observed throughout the Subject Property.

Several piles of shingles and debris were observed around the former school.

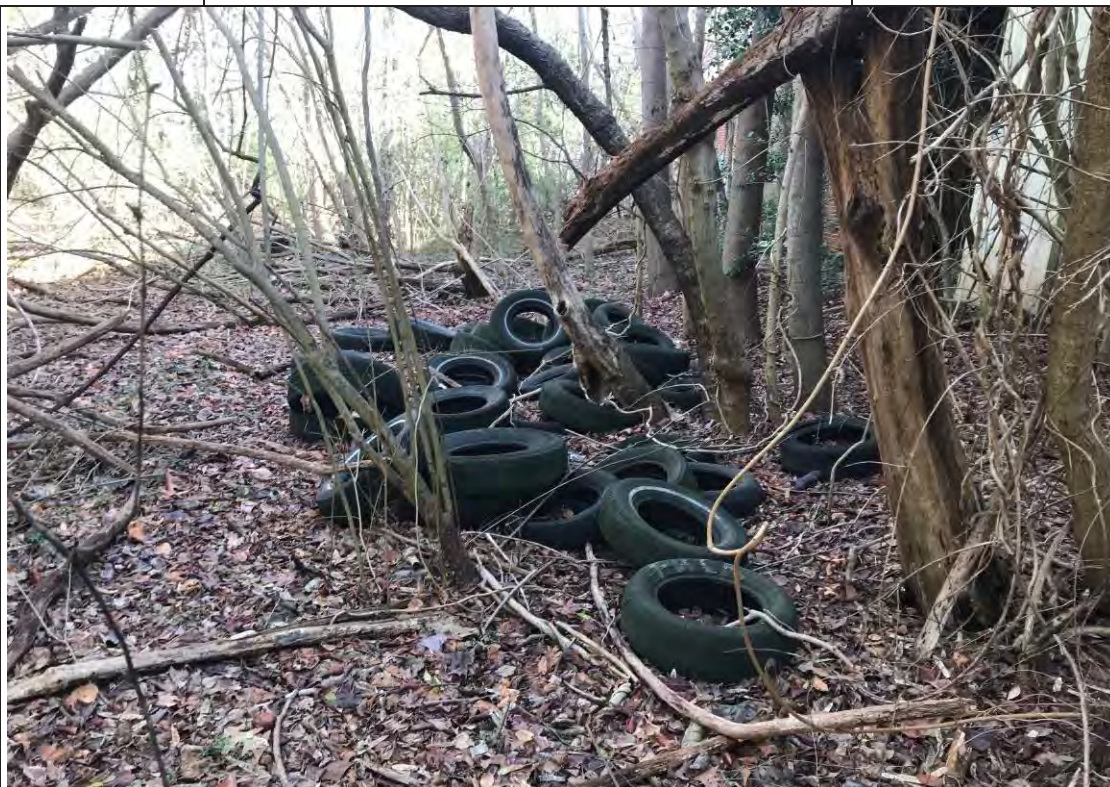
Several piles of tires were observed around the former school.
